Prepared for: South Hampton Property Owners Association
Prepared by: MUHLE Consulting
Date: 14 October 2019
Job number: 18-LTL-002
Property: South Hampton, Kingston Plantation
Subject: Structural Remediation – Field Report #1

Prepared for: South Hampton Property Owners Association
Prepared by: MUHLE Consulting
Date: 9 October 2019
Job number: 18-LTL-002
Property: South Hampton, Kingston Plantation
Subject: Mock-Up – Unit #106

Prepared for: South Hampton Property Owners Association
Prepared by: MUHLE Consulting
Date: 11 October 2019
Job number: 18-LTL-002
Property: South Hampton, Kingston Plantation
Subject: Negative Slope/Ponding at Balconies

Prepared for: South Hampton Property Owners Association
Prepared by: MUHLE Consulting
Date: 27 September 2019
Job number: 18-LTL-002
Property: South Hampton, Kingston Plantation
Subject: Storm Shutters

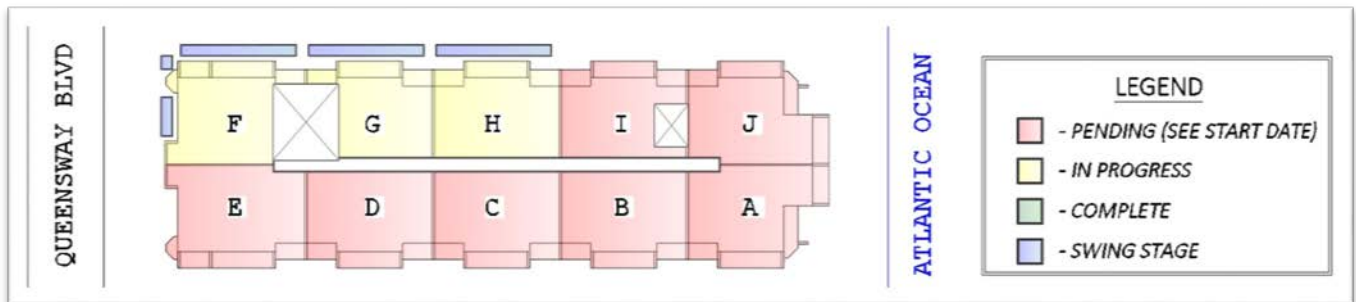
- Mobilization of required equipment began 1 October 2019
- Swing stages in place as shown (see Figure #1) to support 14 October 2019 start date
- Mock-Up at Unit #106 completed and approved (see Appendix “A”)
- Negative slope identified at dispersed units throughout the property and repair method provided (see Appendix “A”)
- Presence of storm shutters identified and recommendation for removal made (see Appendix “A”)
- Remediation activities underway

Figure #1 – Progress Tracker

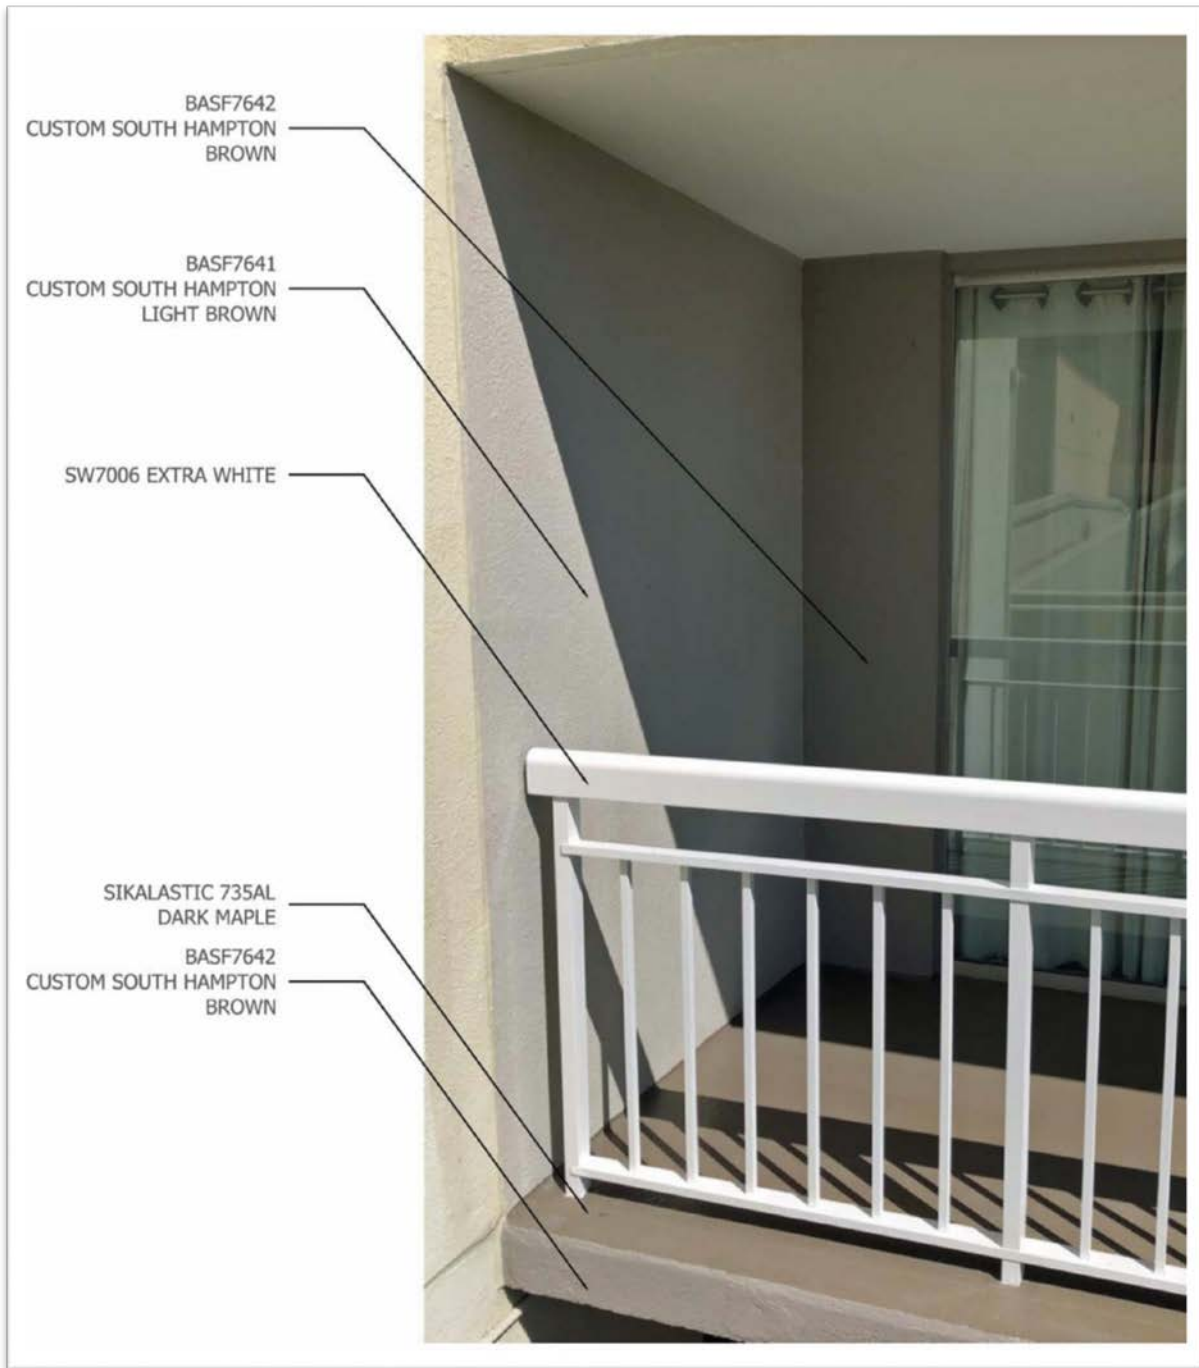
“Figure 1” below is the result of the completed mock-up. Please review color choices, their placement and workmanship quality, and indicate acceptability via signature (see P.3).

Figure #1 – Mock-Up at Unit #106

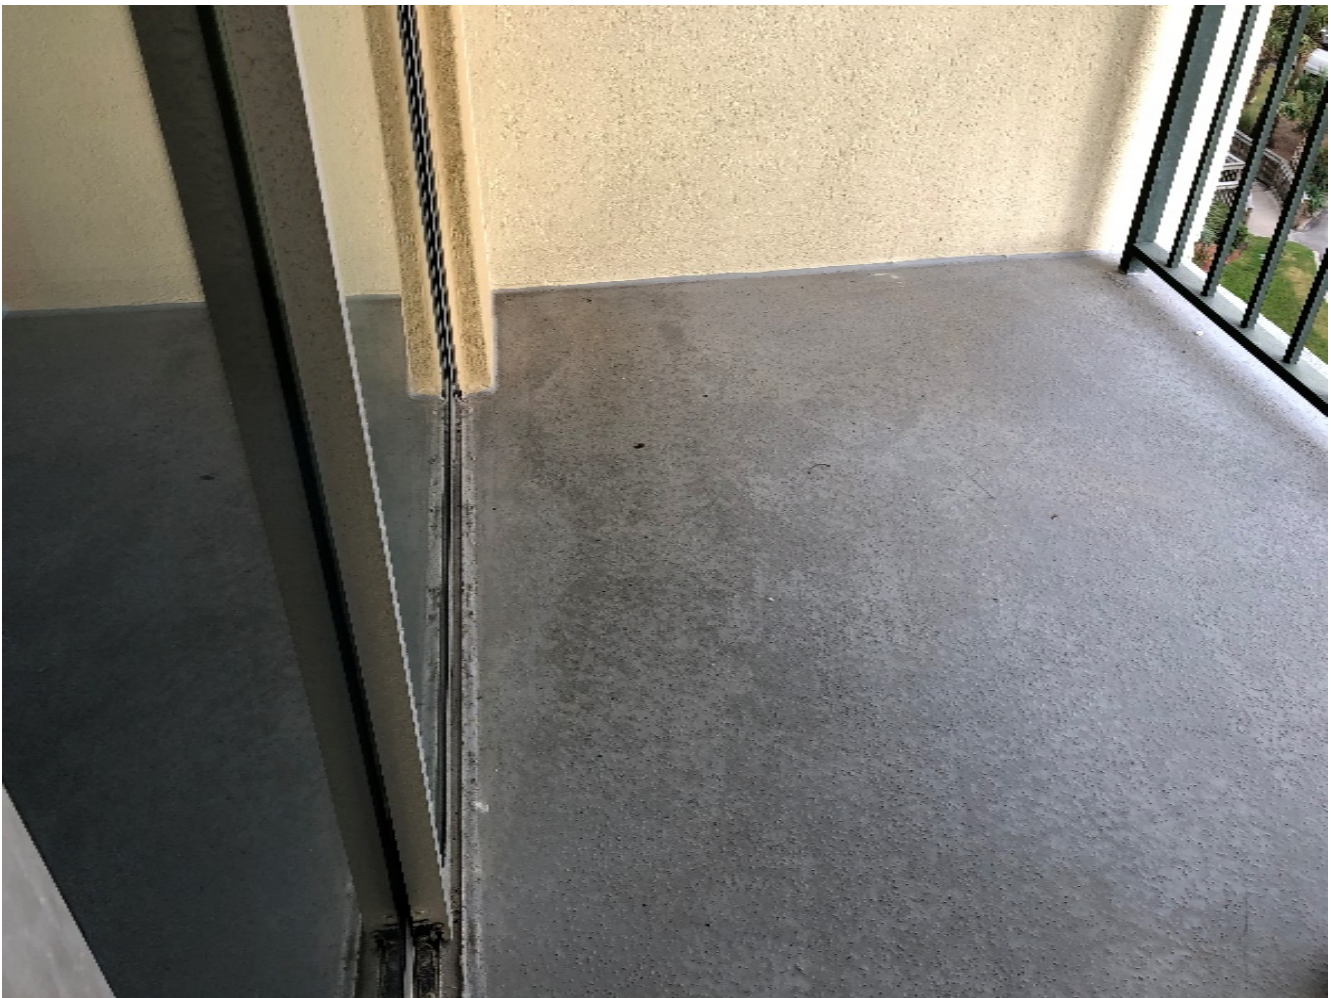
It has been brought to our attention that certain balconies at the above-referenced property exhibit ponding of water at the exterior balconies. The finished concrete should provide a uniform positive slope from the wall interface toward the balcony edge in order to shed any water present on the balcony surface. Inconsistencies in the finishing of the concrete at the time of construction appear to be the root cause of the standing water/ponding (see Figure #1).

Figure #1 – Ponding due to Negative Slope

In order to remedy the negative slope, the following steps are required:

1. Remove existing deck coating to bare concrete
2. Apply Sika® Level SkimCoat (or similar) levelling compound to provide positive slope
3. Apply Sikalastic® Primer to exposed concrete
4. Apply Sikalastic® 710 Base over primer coat
5. Apply oven-dried sand and Sikalastic® 710 as an intermediate coat
6. Apply Sikalastic® 735AL top coat

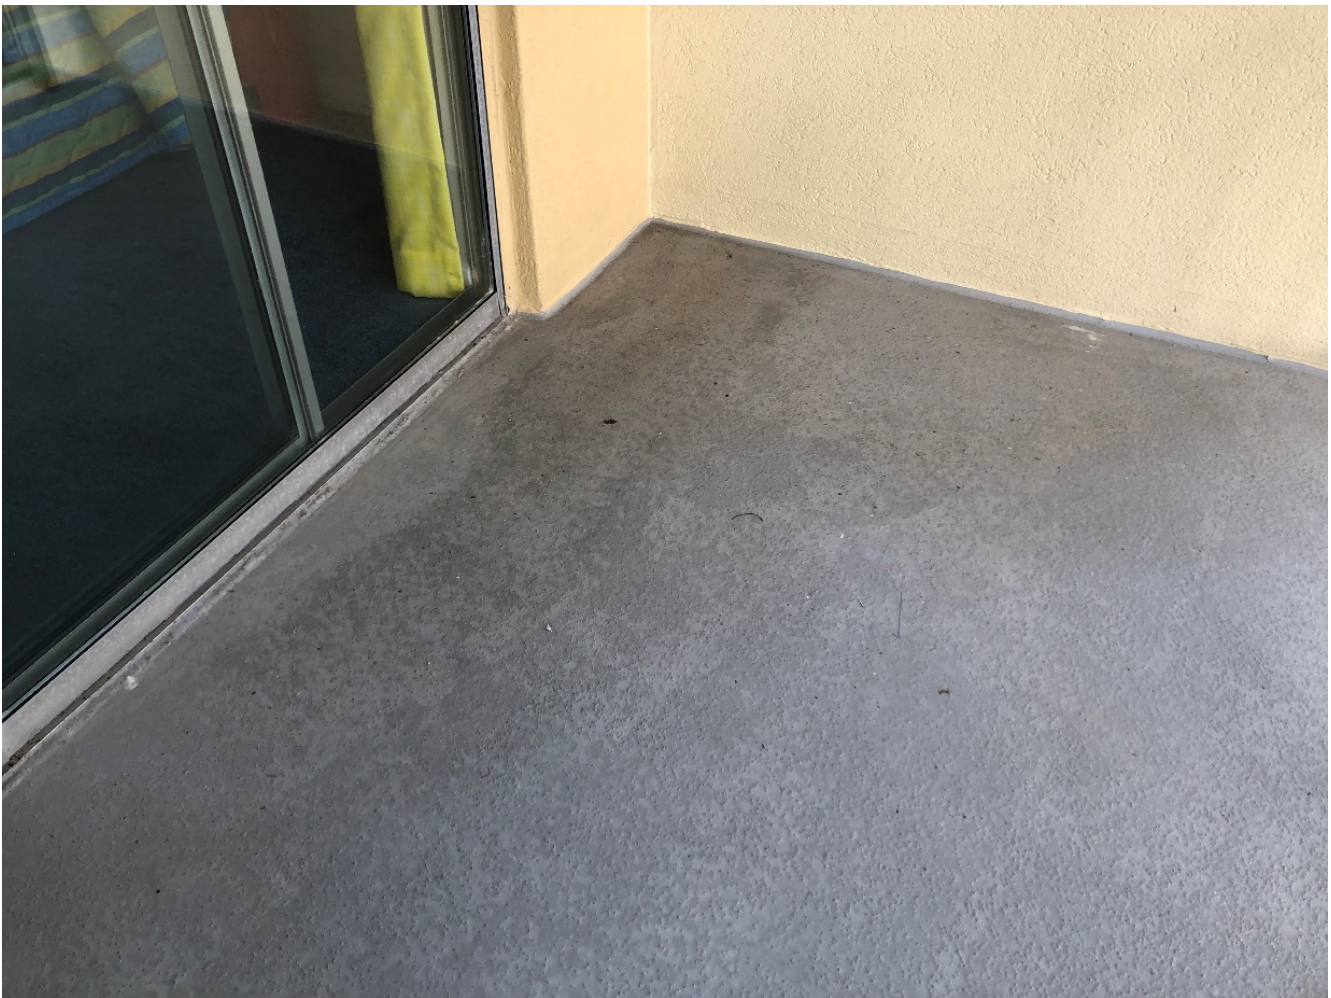
Due to the relatively low threshold height of the existing sliding doors (see Figure #2), the height required to remedy the negative slope and provide sufficient positive slope may exceed the existing threshold height. In the event this occurs, an aluminum angle (or similar) would be required across the width of the balcony floor/wall interface. This angle would be mechanically fastened to the concrete slab and act as a form to allow the levelling compound to terminate at the required height.

Figure #2 – Sliding Door Threshold
