Prepared for: South Hampton Property Owners Association
Prepared by: MUHLE Consulting
Period: 16 November 2019 – 30 November 2019
Job number: 18-LTL-002
Property: South Hampton, Kingston Plantation
Subject: Structural Remediation – Field Report #4

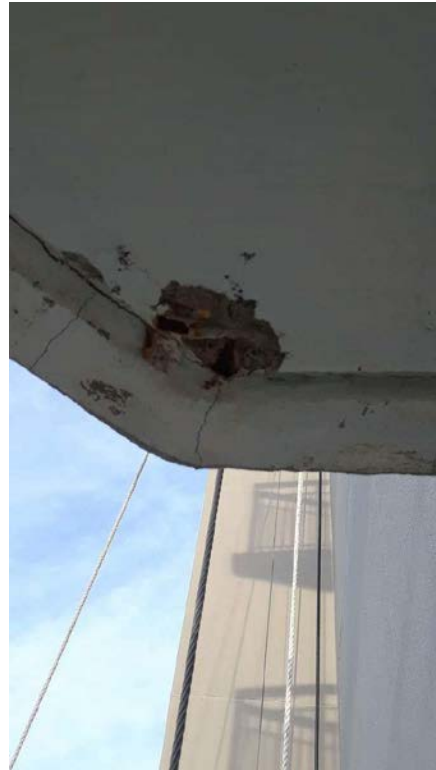
- Ceiling damage (concrete spalling) identified at Unit #1002 (corner balcony) (see Figure #5 – 7)
- Storm shutter holes and coating damage present at Unit #1102 (see Figure #8 – 11)

- EIFS water damage identified at NE corner of Stack #9(J)
- Following repair methods forthcoming:
 - o Carbon fiber repair at removed storm shutter balcony edges
